SOLAS Retrofit Solutions

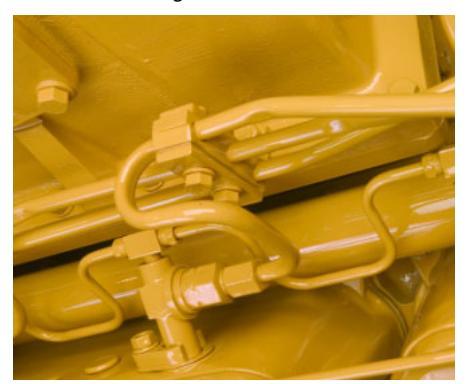
Mechanical engine

Double-walled fuel or oil lines*

- Protects all external high-pressure fuel or oil delivery lines between the pumps and injectors with a jacketed piping system, which is capable of containing fuel or oil from a highpressure failure
- Features an outer pipe into which the high-pressure fuel pipe is placed, forming a permanent assembly
- Includes a leakage collection system with an alarm
- Meets SOLAS regulation 15.2.9

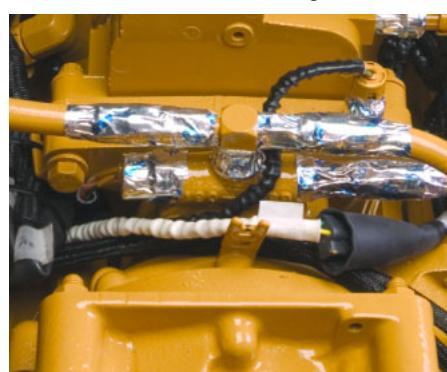
Mechanical or Electronic engine

Improved joint screening

- Screens low-pressure oil and fuel lines to prevent leaks from spraying hot surfaces, machinery intakes or other sources of ignition
- Meets SOLAS regulation 15.2.11

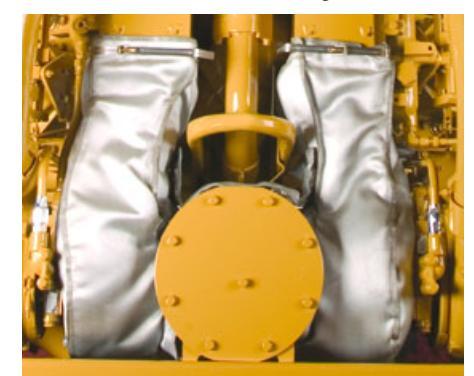
Mechanical or Electronic engine

Hot surface insulation

- Insulates all surfaces with temperatures above 220°C (428°F), which can be impinged as a result of a fuel system failure
- Insulates the turbocharger exhaust casing when the turbocharger exceeds temperatures of 220°C (428°F)—If the compressor doesn't exceed the temperature limit, insulation is not needed
- Meets SOLAS regulation 15.2.10
- * Note: Double-walled lines are not required for any engine below a 375 kW rating if it was built before July 1, 1998. All engines with high-pressure fuel or oil lines installed after July 1, 1998, do require double-walled fuel lines. Some Cat engines (D346, D348, D349, D353, and 3126B) don't have all the components necessary to meet this regulation. We'll work with you on a case-by-case basis to develop a solution.

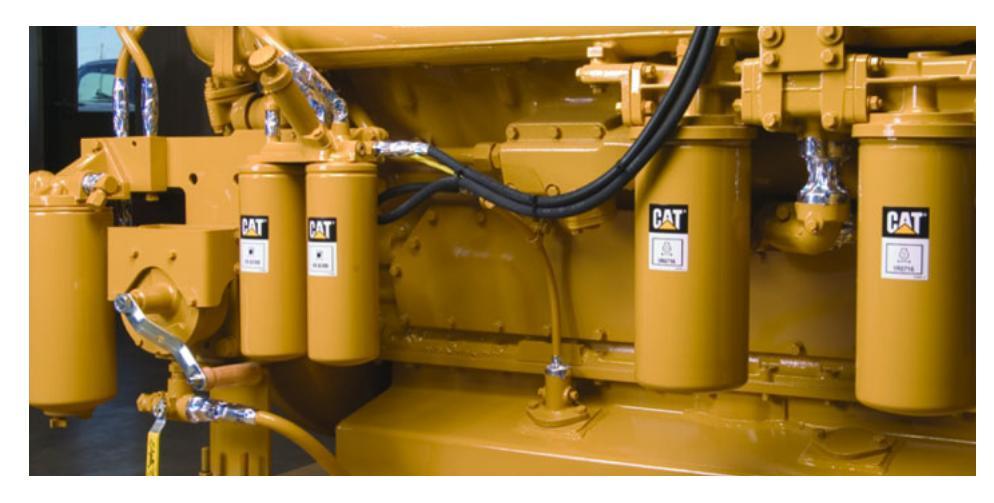
Joint screening on oil and fuel lines

Due to lower operating pressure, all oil and fuel filter bases, fuel-priming pumps and oil-sump connections require joint screening.

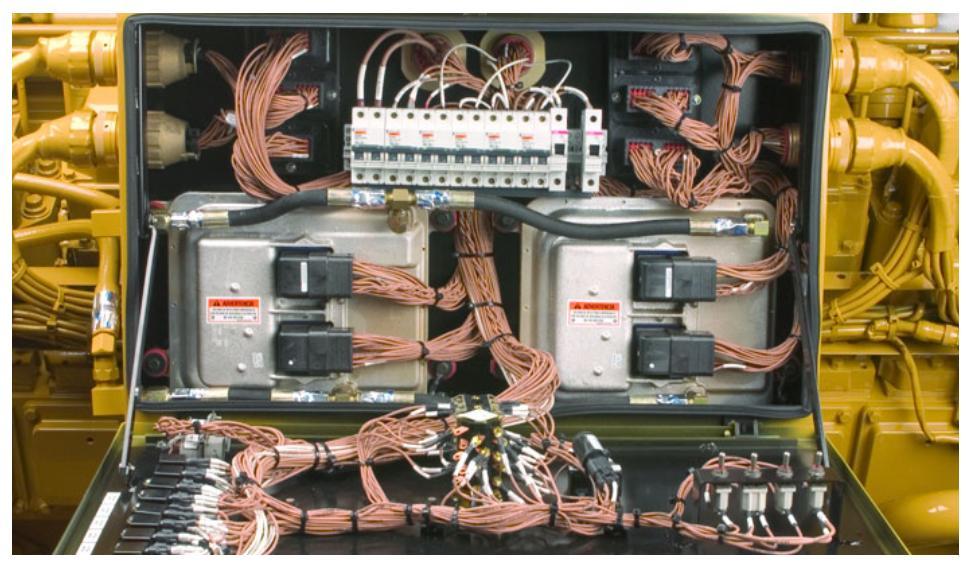
As heat is generated from the circuit current going to the solenoid, the electronic control module requires joint screening to protect it by redirecting a possible leak or spray away from the electronic control module. This ensures:

Joint screening on electronic control module

- Microcomputer systems must be protected to control the heat flow.
- Low-pressure fuel cools the electronic control module.
- Heat is generated from an electrical current going to the solenoid. Joint screening protects the analog and/or digital electronics of the microcomputer.

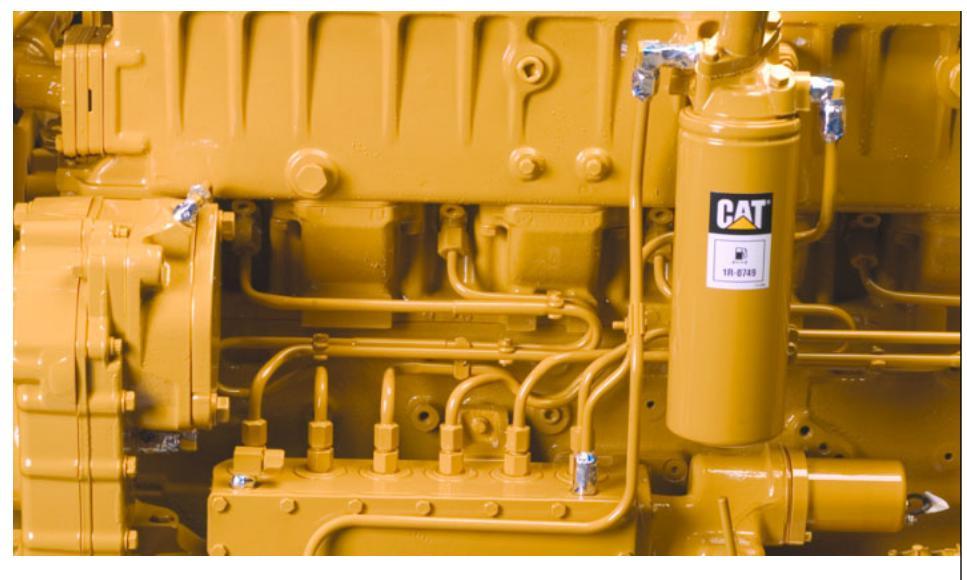
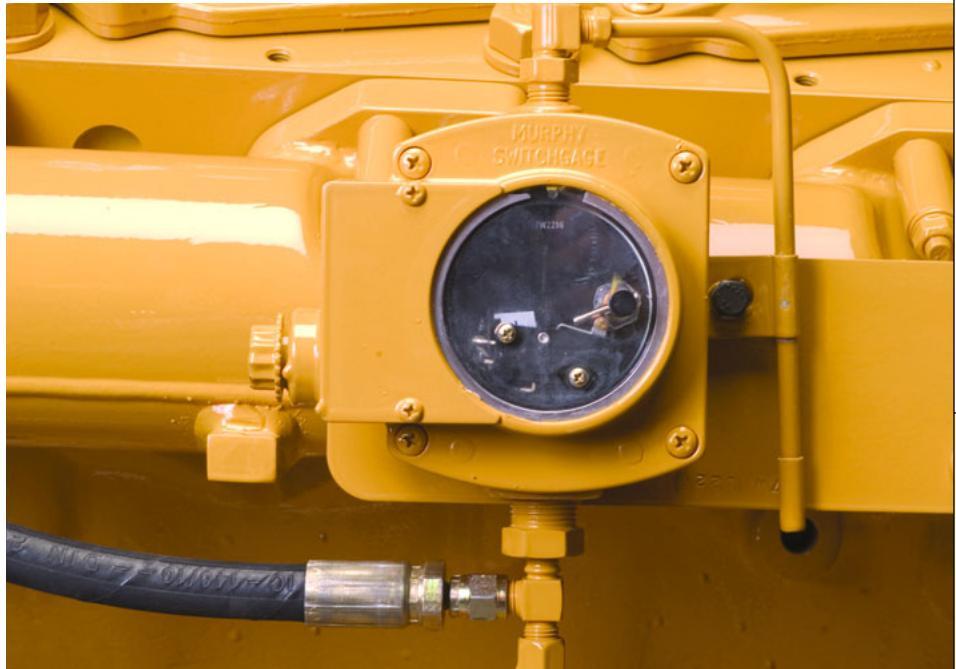
Double-walled oil and fuel lines and joint screening

- Double-walled lines contain highpressure fluids going into the cylinders. Turbulent flow motion mandates this jacketed piping system which protects high pressure flow motion from failure.
- Double-walled lines with leaking fluid will flow the leakage down to a drain line and capture the excess. An alarm sounds when contents reach certain levels.
- Low-pressure lines going to and from the filter are screened to prevent leaks or sprays near hot surfaces which can cause ignition.
